**SITE ASSESSMENT REPORT
FOR
FROST MANUFACTURING COMPANY
KENOSHA, KENOSHA COUNTY, WISCONSIN
TDD: S05-9606-022
PAN: 6N2201SI**

January 27, 1997

**UNITED STATES ENVIRONMENTAL PROTECTION AGENCY
Emergency and Enforcement Response Branch
77 West Jackson Boulevard
Chicago, Illinois 60604**

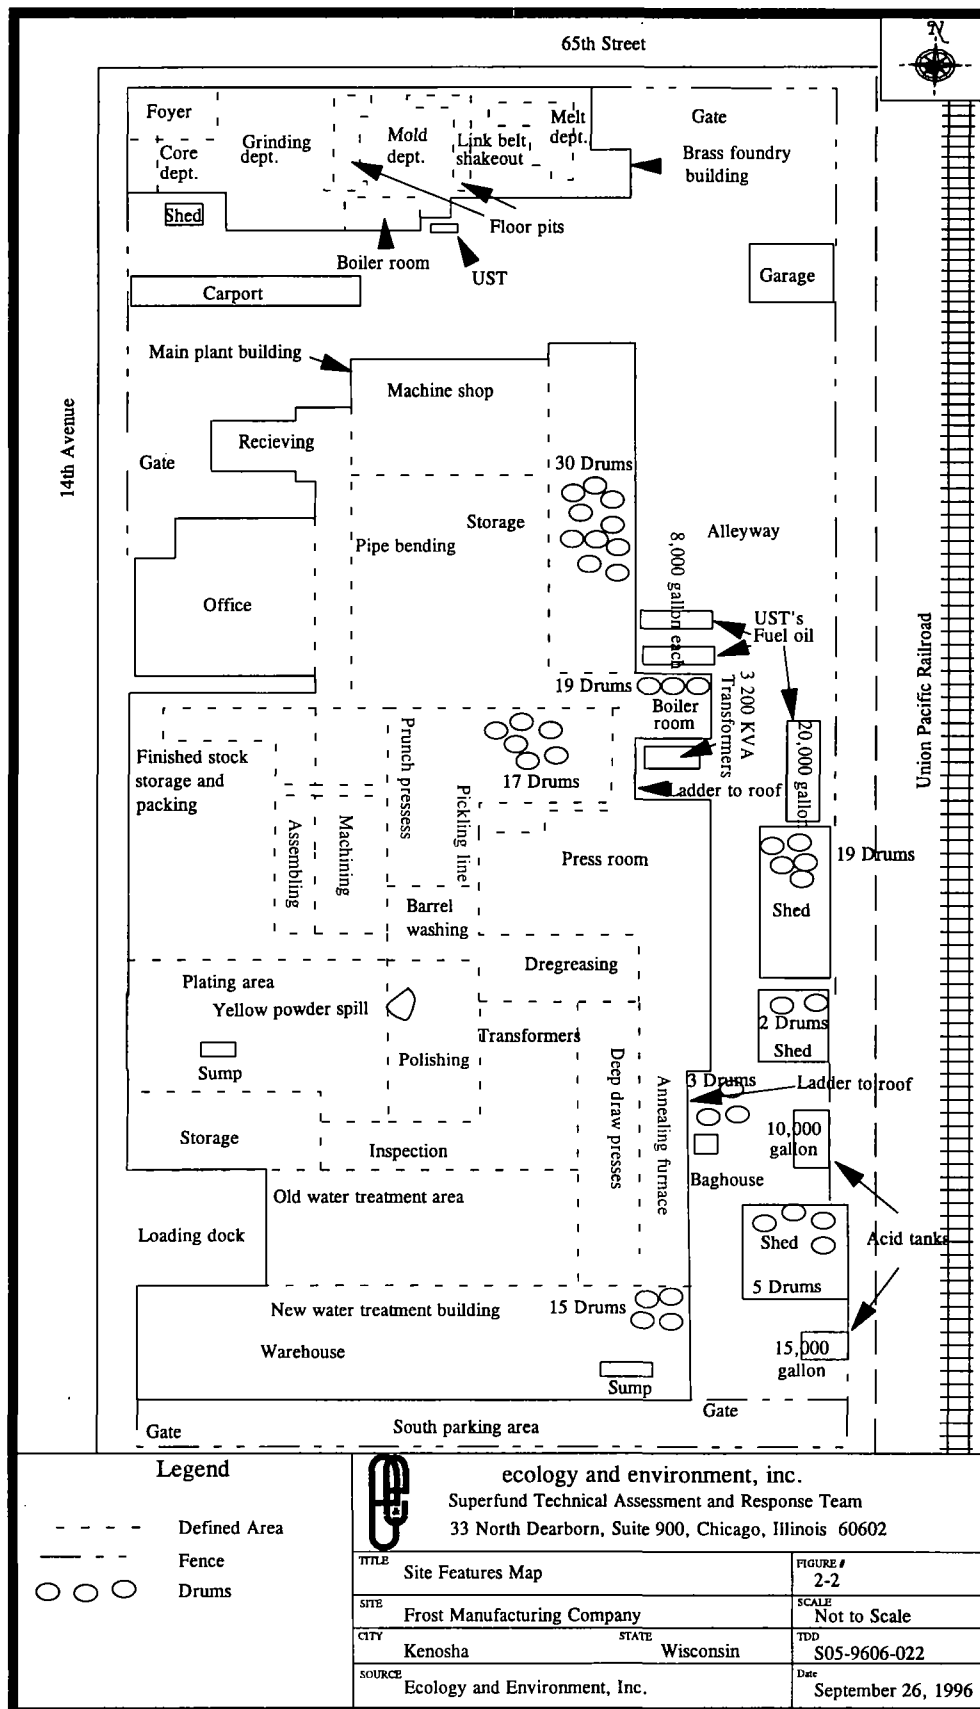
The site is comprised of the brass foundry building, located on the northwest portion of the site; the main plant building where the plating operations and production processes occurred, located south of the foundry building; four underground storage tanks (USTs) for fuel oil, three located in the alley east of the main plant and one located south of the brass foundry building; a carport located between the brass foundry building and the main plant building; and three storage sheds and a garage, located east of the main plant building and west of the Union Pacific Railroad (UPRR) (formerly the Chicago and Northwestern Railroad). The brass foundry building is in good condition and all equipment has been removed from the building, leaving several pits. The brass foundry building consisted of six main areas: a core department, a grinding department, a mold department, a link belt shakeout, a melt department, and a boiler room (Figure 2-2).

Three sheds and a garage were located along the eastern side of the site. The southernmost shed is constructed of wood. The next two sheds to the north were constructed of steel and concrete. The sheds were used to store old equipment and had some equipment, parts, and miscellaneous containers. All sheds were in fair condition. The garage was located to the north of the sheds and is constructed of concrete block. The garage was used to store foundry material and was empty, except for a dismantled engine (Figure 2-2).

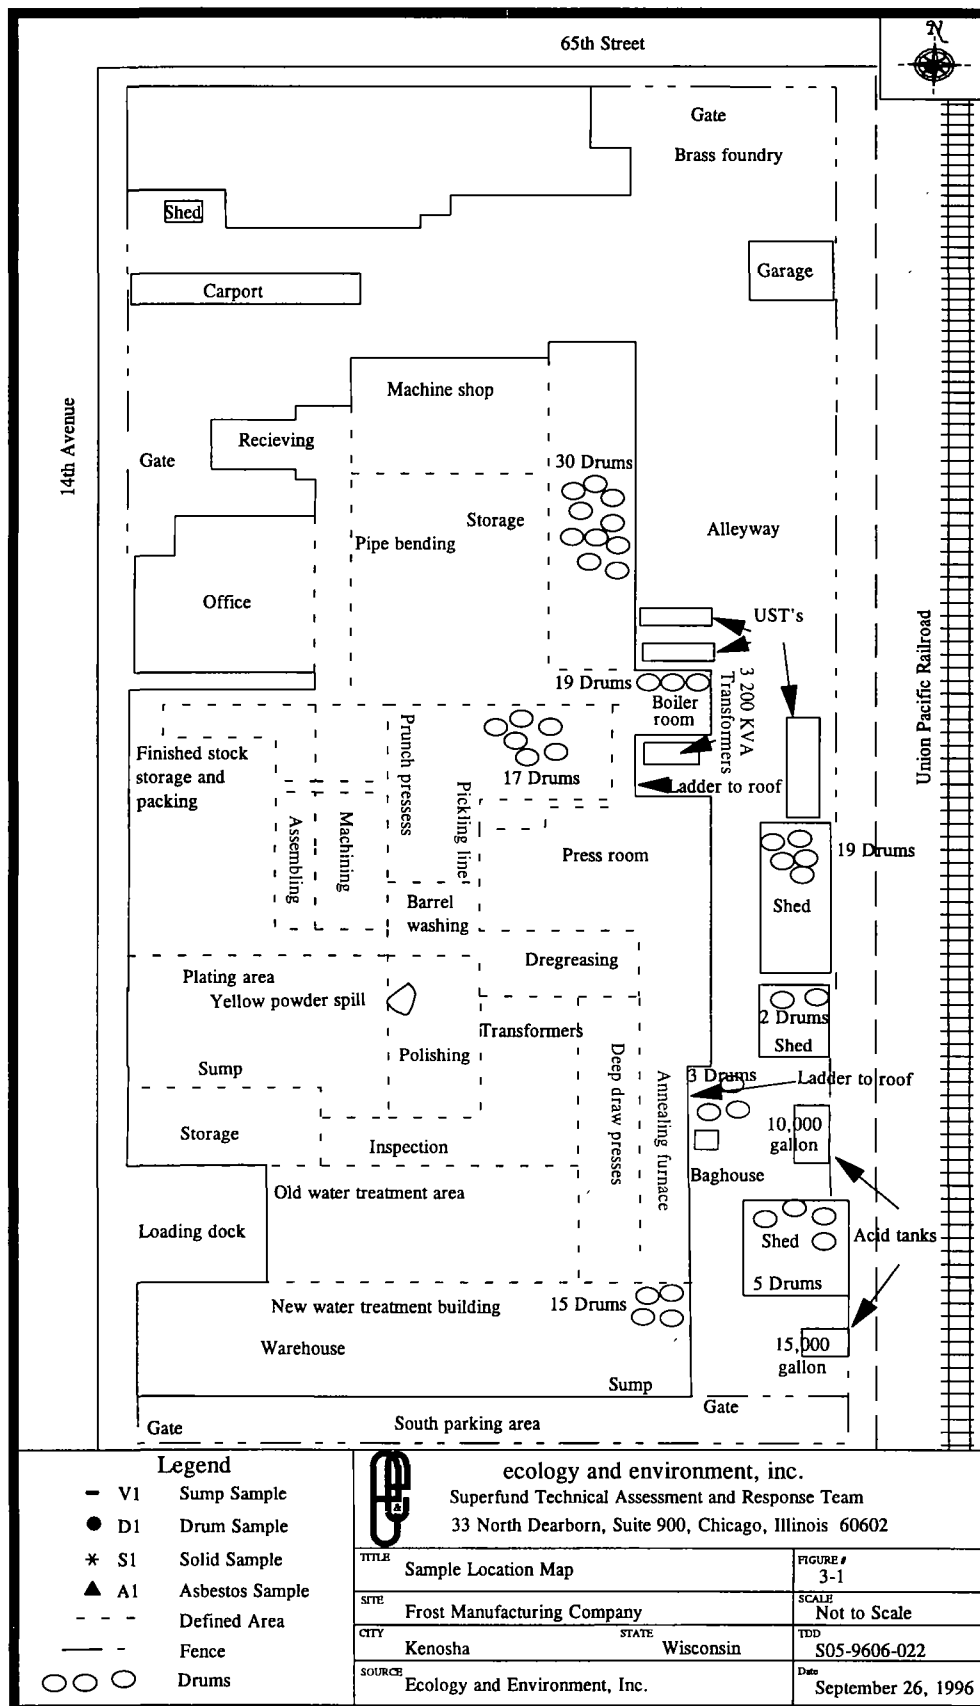
A site safety meeting was conducted and hazards associated with the FMC site were discussed. A site reconnaissance was conducted to observe site conditions and determine sample locations (Figure 3-1). During this site reconnaissance, site features were photographed (Appendix A). Air monitoring was conducted using a 10.2 eV HNU photoionization detector (PID) for screening organic vapors. Organic vapor readings monitored throughout the site with the HNU were either below or at the background level of 1 part per million (ppm). Sampling activities were conducted in Level B protective equipment.

During the reconnaissance, nine sample locations were marked and numerous observations were made. Two transformer areas were located on the east side of the main plant. All utilities at the FMC site had been turned off by the City of Kenosha. Four USTs were located by their stand pipes, three in the alley east of the main plant and one south of the brass foundry building. According to WDNR file information, one UST capacity was 20,000 gallons, two were 8,000 gallons, and one was of unknown capacity.

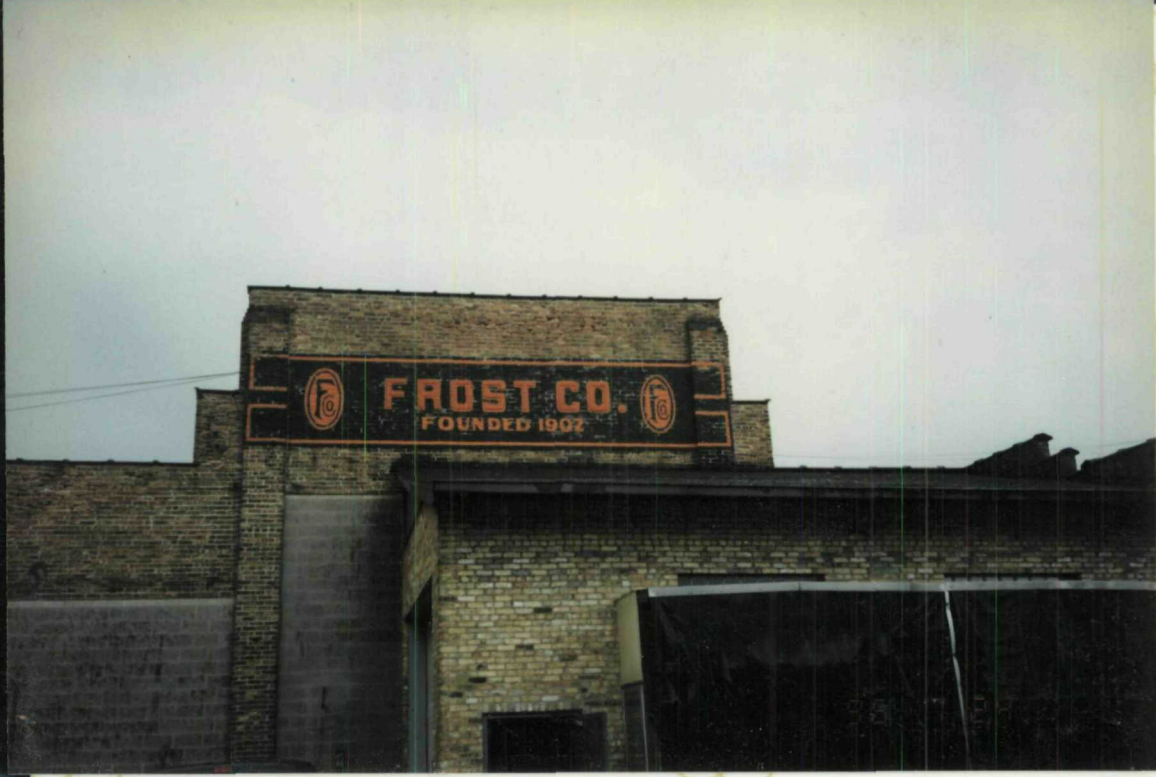
Site: Frost Manufacturing Company **Date:** 7-24-96 **Direction:** East
Camera: Olympus Infinity 35mm **Photographer:** J. Nordine
Subject: Sign on building face "Frost Co. Founded 1902."

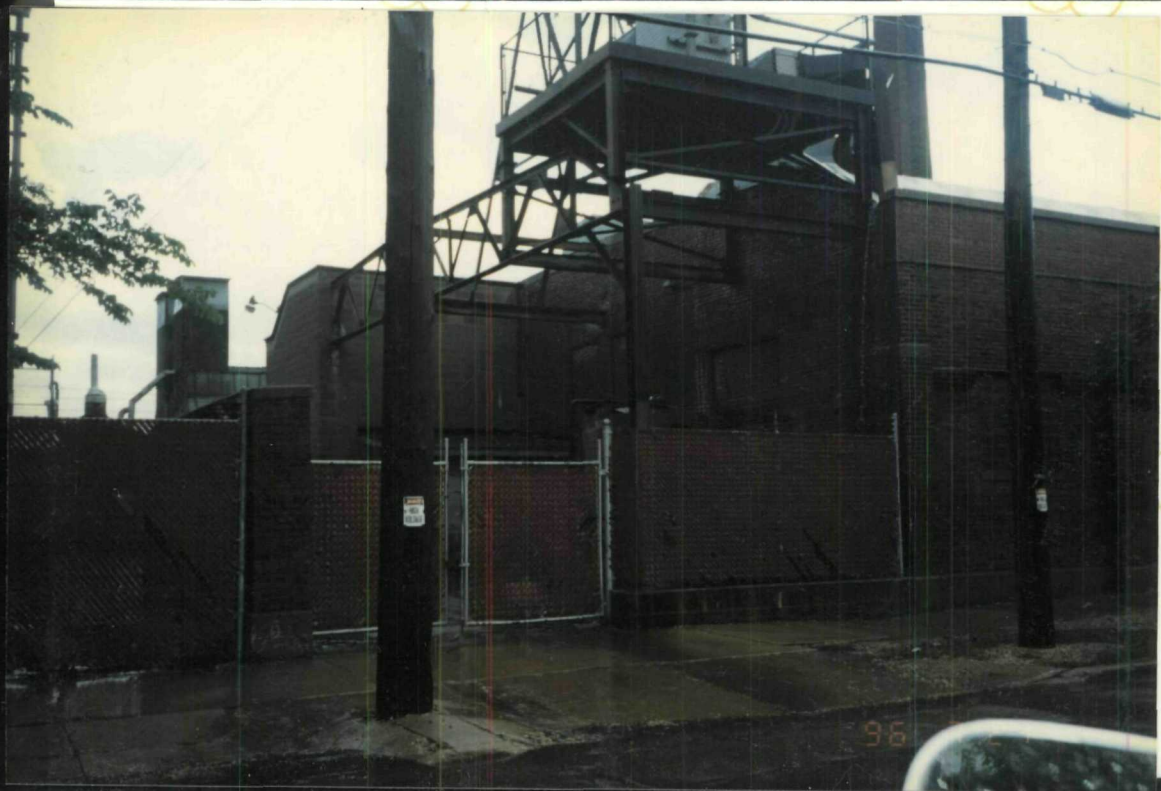
Site: Frost Manufacturing Company **Date:** 7-24-96 **Direction:** South
Camera: Olympus Infinity 35mm **Photographer:** J. Nordine
Subject: North gate of Frost Manufacturing Company. Note the gate is locked, but still accessible.

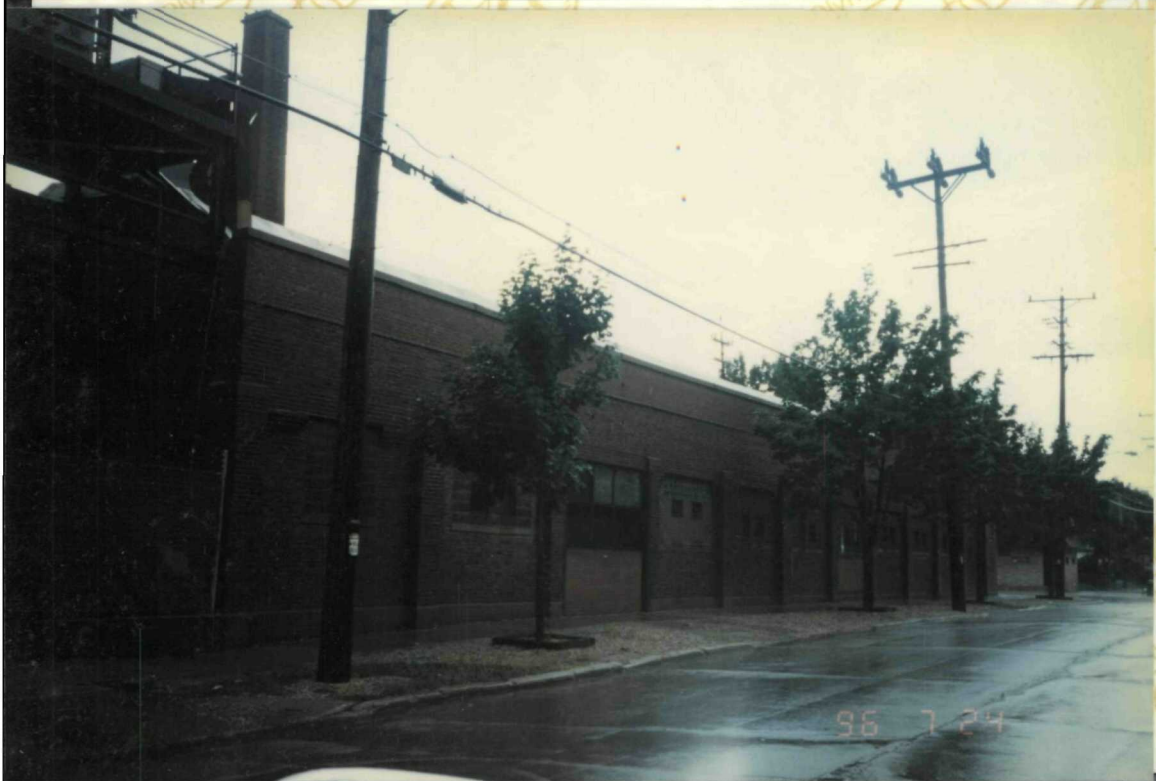
Site: Frost Manufacturing Company **Date:** 7-24-96 **Direction:** Southwest
Camera: Olympus Infinity 35mm **Photographer:** J. Nordine
Subject: North side of the brass foundry building along 66th Street.

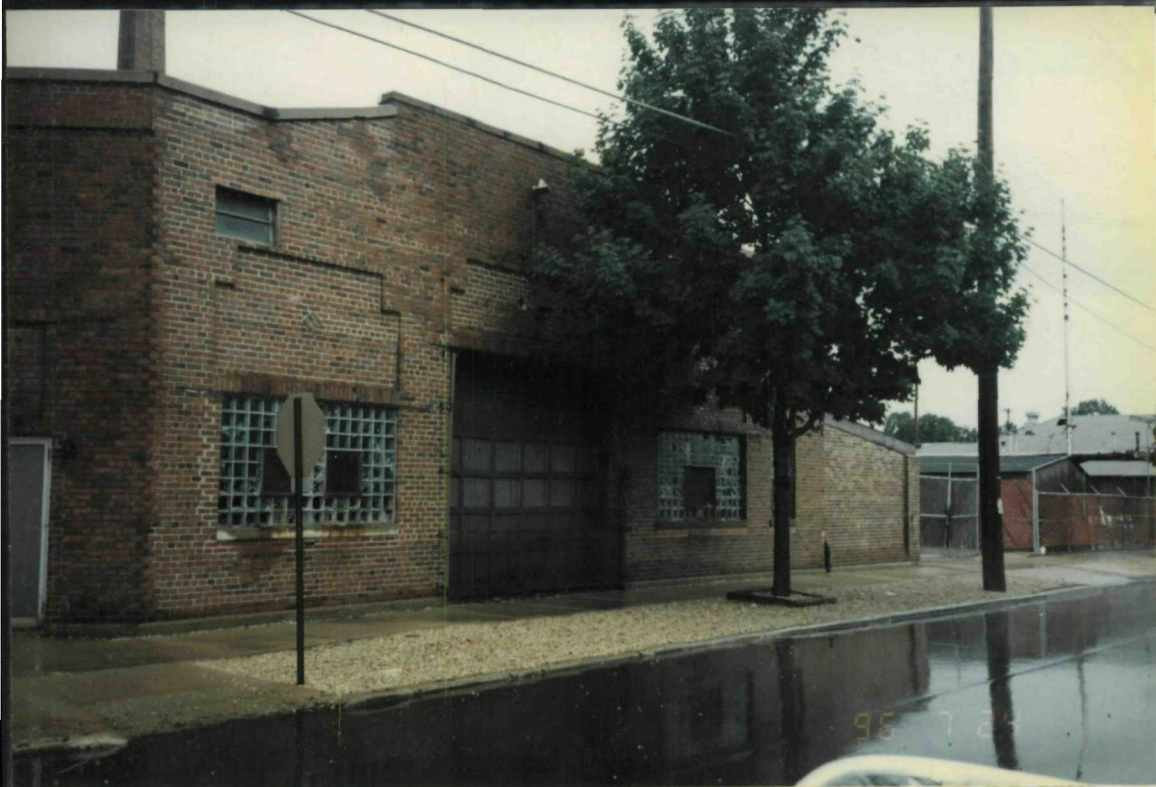
Site: Frost Manufacturing Company **Date:** 7-24-96 **Direction:** West
Camera: Olympus Infinity 35mm **Photographer:** J. Nordine
Subject: The west front of the brass foundry building.

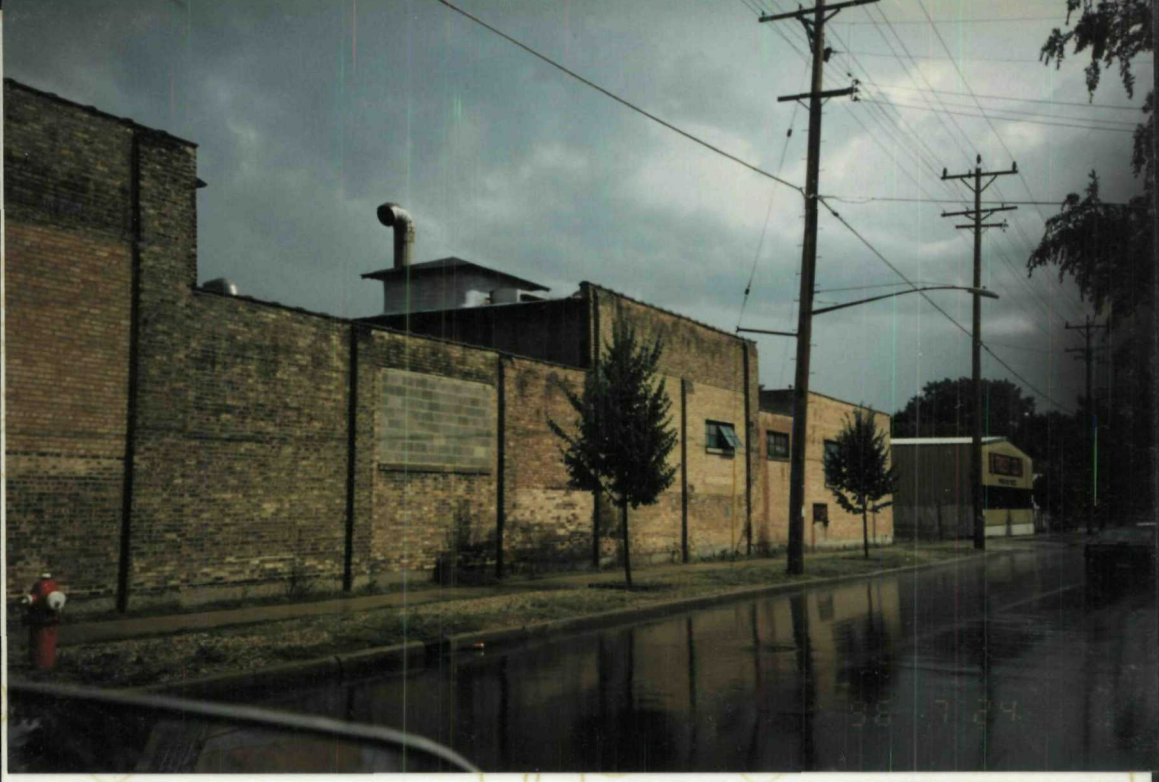
Site: Frost Manufacturing Company **Date:** 7-24-96 **Direction:** Southwest
Camera: Olympus Infinity 35mm **Photographer:** J. Nordine
Subject: View of the west side of the main plant building.

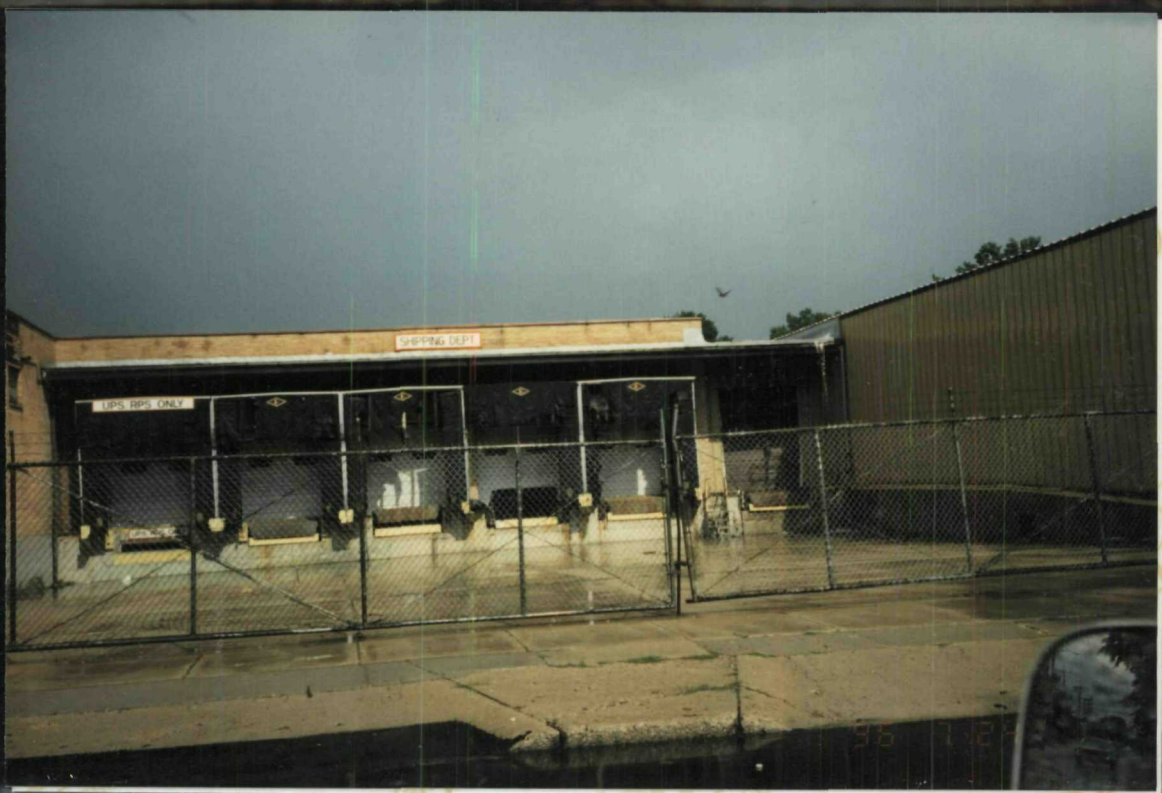
Site: Frost Manufacturing Company **Date:** 7-24-96 **Direction:** East
Camera: Olympus Infinity 35mm **Photographer:** J. Nordine
Subject: View of the loading dock area of the main plant building.

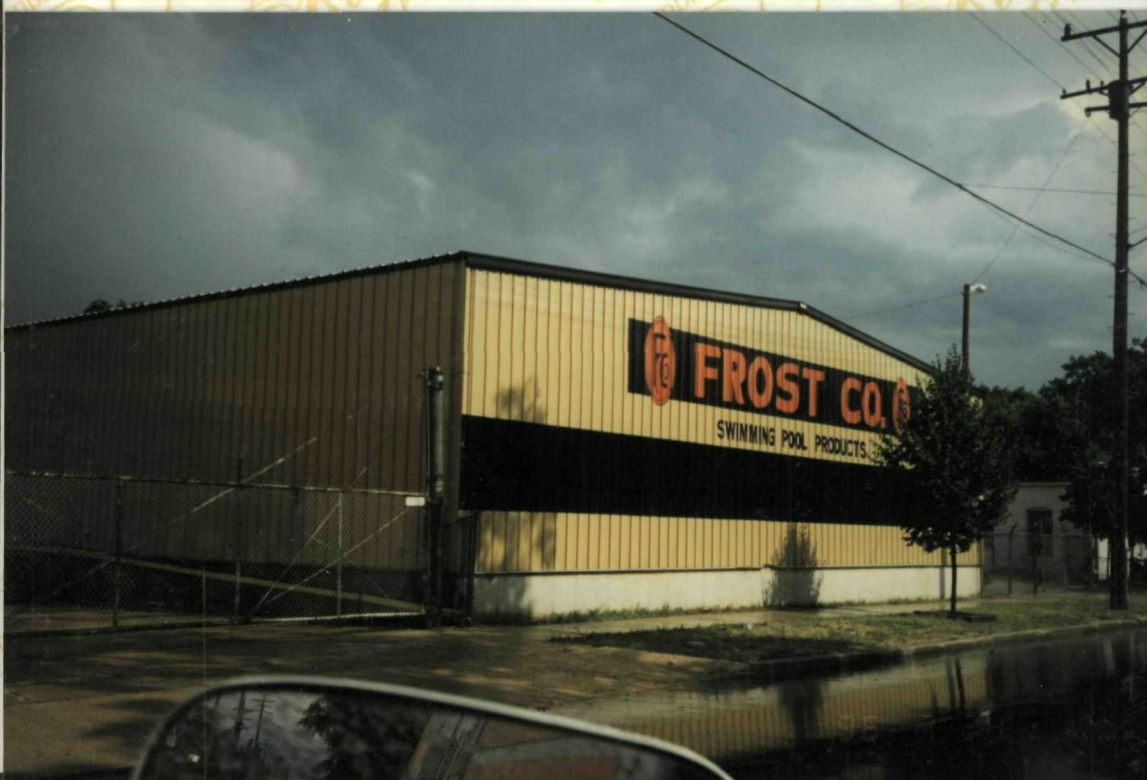
Site: Frost Manufacturing Company **Date:** 7-24-96 **Direction:** Southeast
Camera: Olympus Infinity 35mm **Photographer:** J. Nordine
Subject: View of the southwest end of the main plant building.

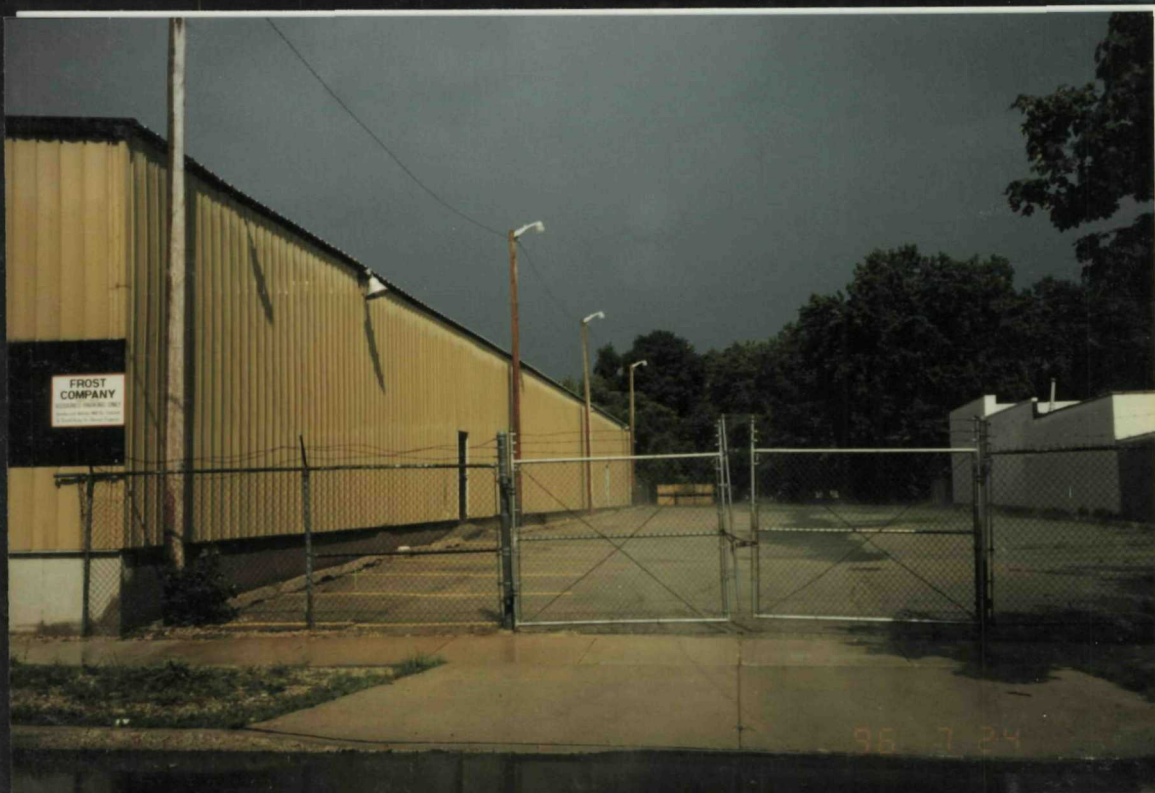
Site: Frost Manufacturing Company **Date:** 7-24-96 **Direction:** East
Camera: Olympus Infinity 35mm **Photographer:** J. Nordine
Subject: The south gate was located along 14th Avenue. Note that access is possible even with the gate locked.

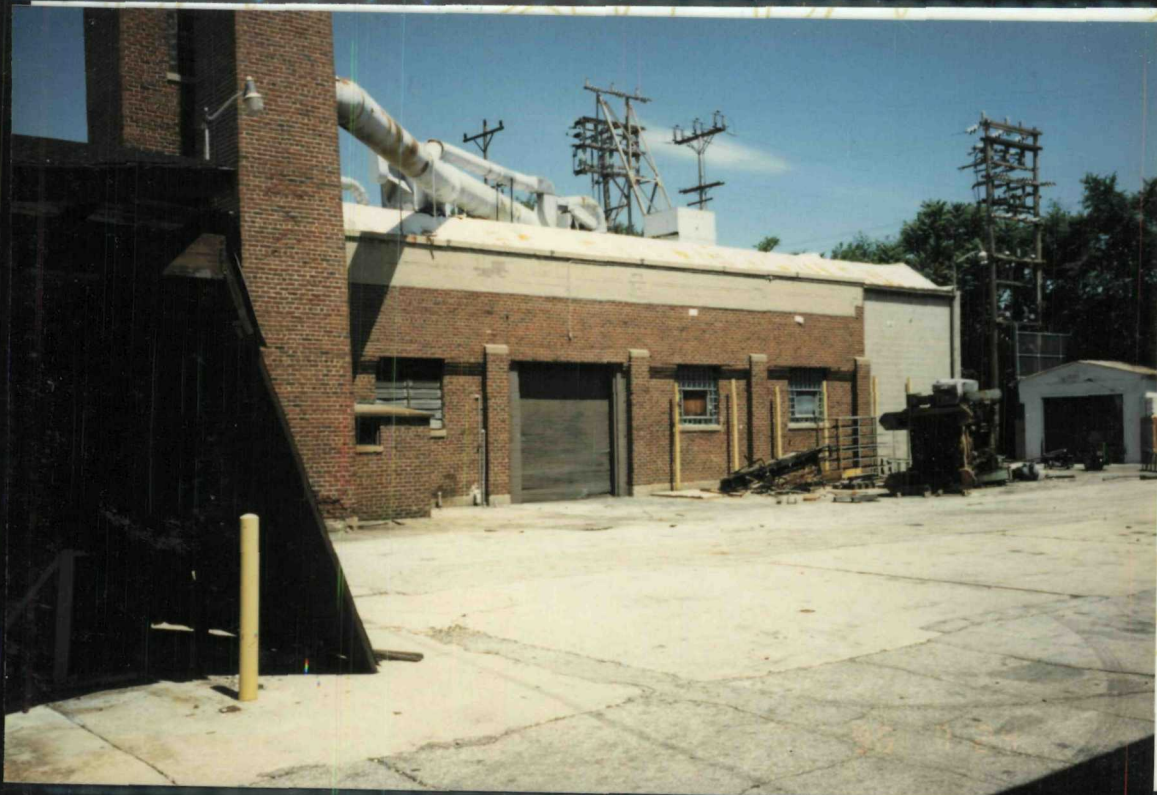
Site: Frost Manufacturing Company **Date:** 7-24-96 **Direction:** Northeast
Camera: Olympus Infinity 35mm **Photographer:** J. Nordine
Subject: The southeast end of the brass foundry building.

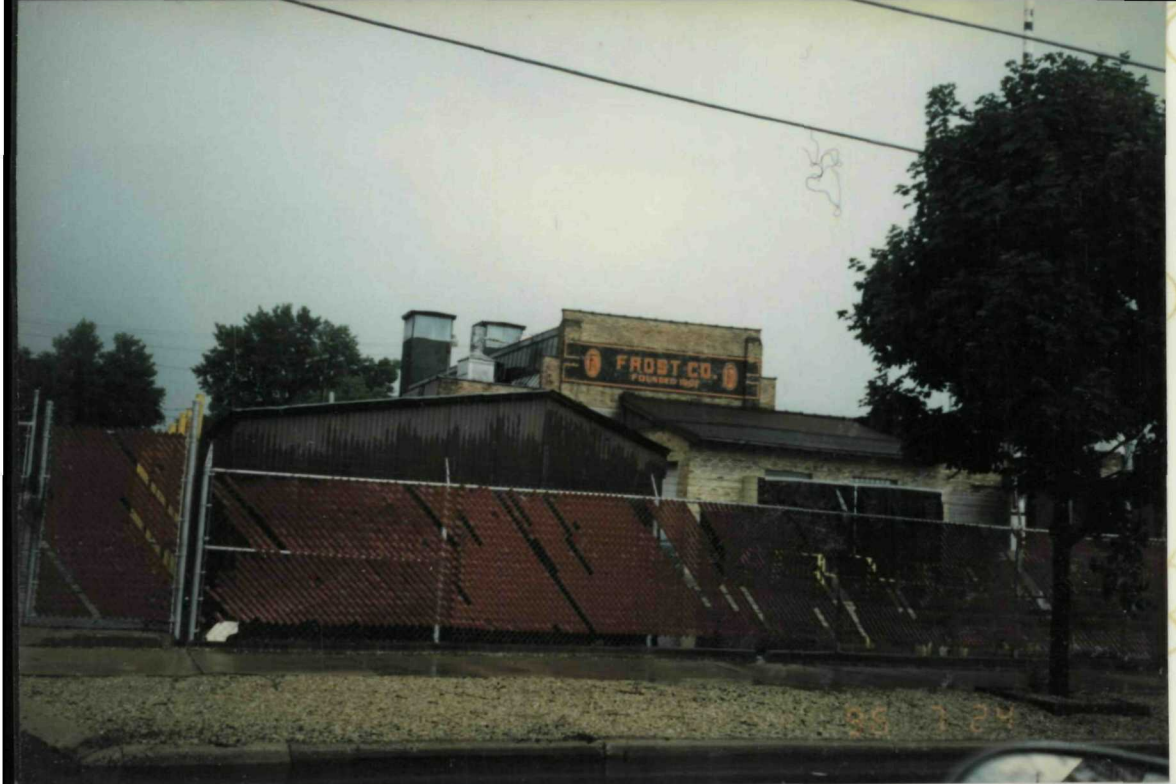
Site: Frost Manufacturing Company **Date:** 7-24-96 **Direction:** East
Camera: Olympus Infinity 35mm **Photographer:** J. Nordine
Subject: View of the fence along 14th Avenue.

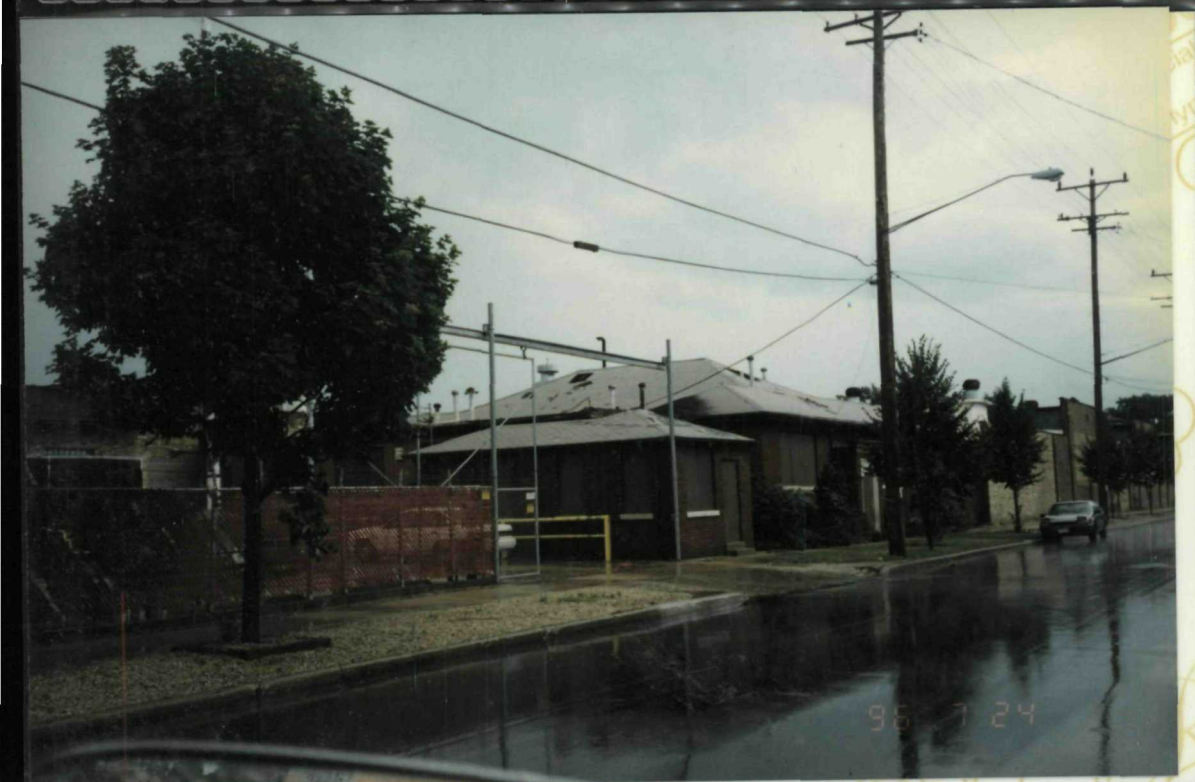
Site: Frost Manufacturing Company **Date:** 7-24-96 **Direction:** Southeast
Camera: Olympus Infinity 35mm **Photographer:** J. Nordine
Subject: View of the second gate along 14th Avenue.

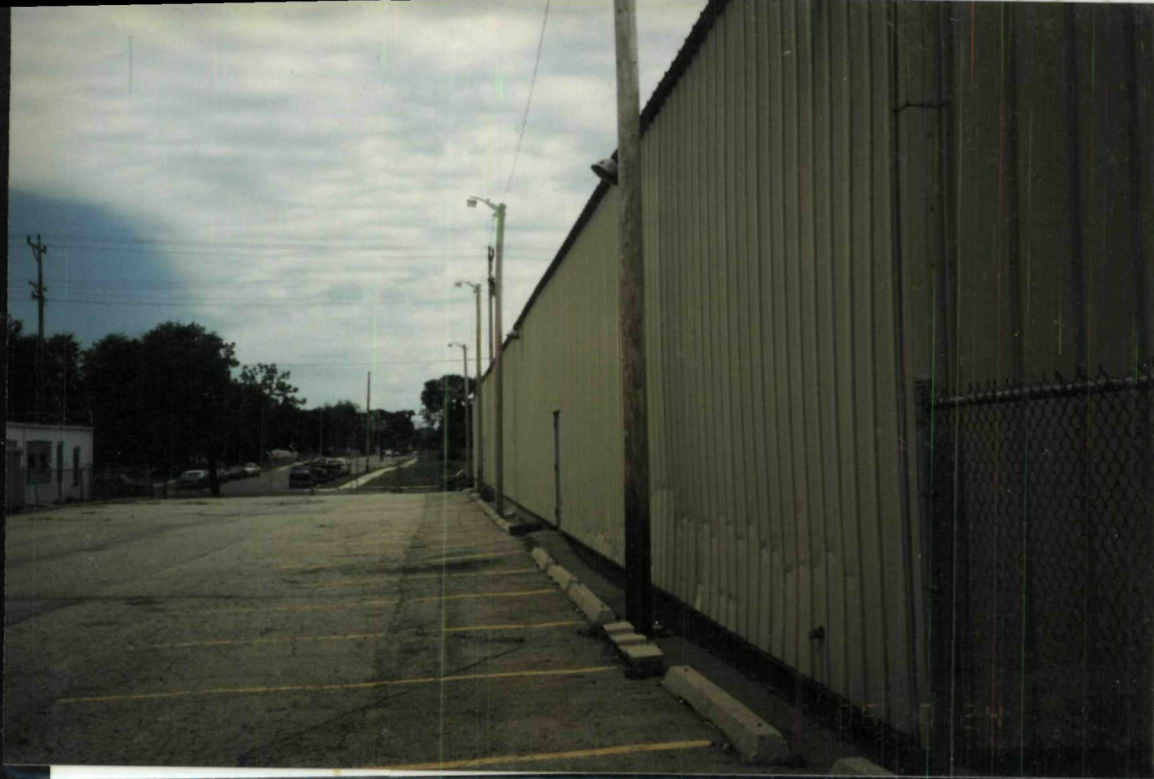
Site: Frost Manufacturing Company **Date:** 7-24-96 **Direction:** West
Camera: Olympus Infinity 35mm **Photographer:** J. Nordine
Subject: The parking area south of the main plant building.

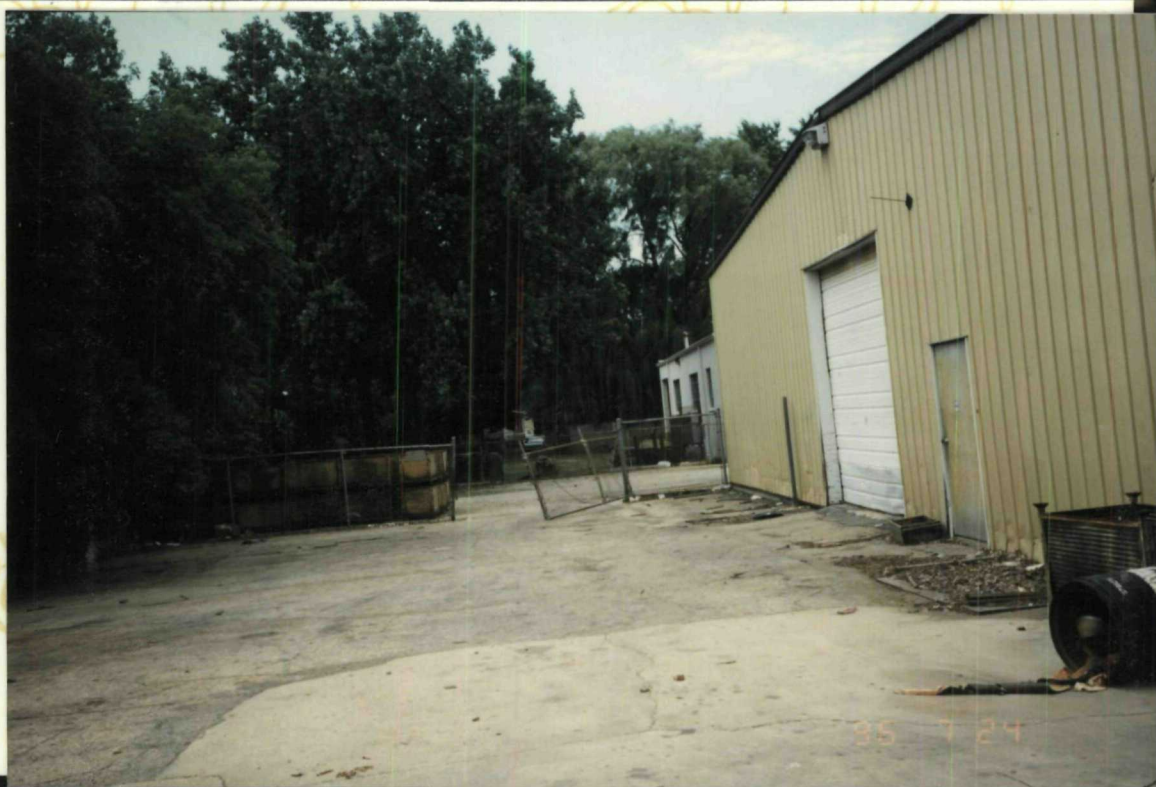
Site: Frost Manufacturing Company **Date:** 7-24-96 **Direction:** South
Camera: Olympus Infinity 35mm **Photographer:** J. Nordine
Subject: The southeast gate to the alley was open at the time of the site assessment.

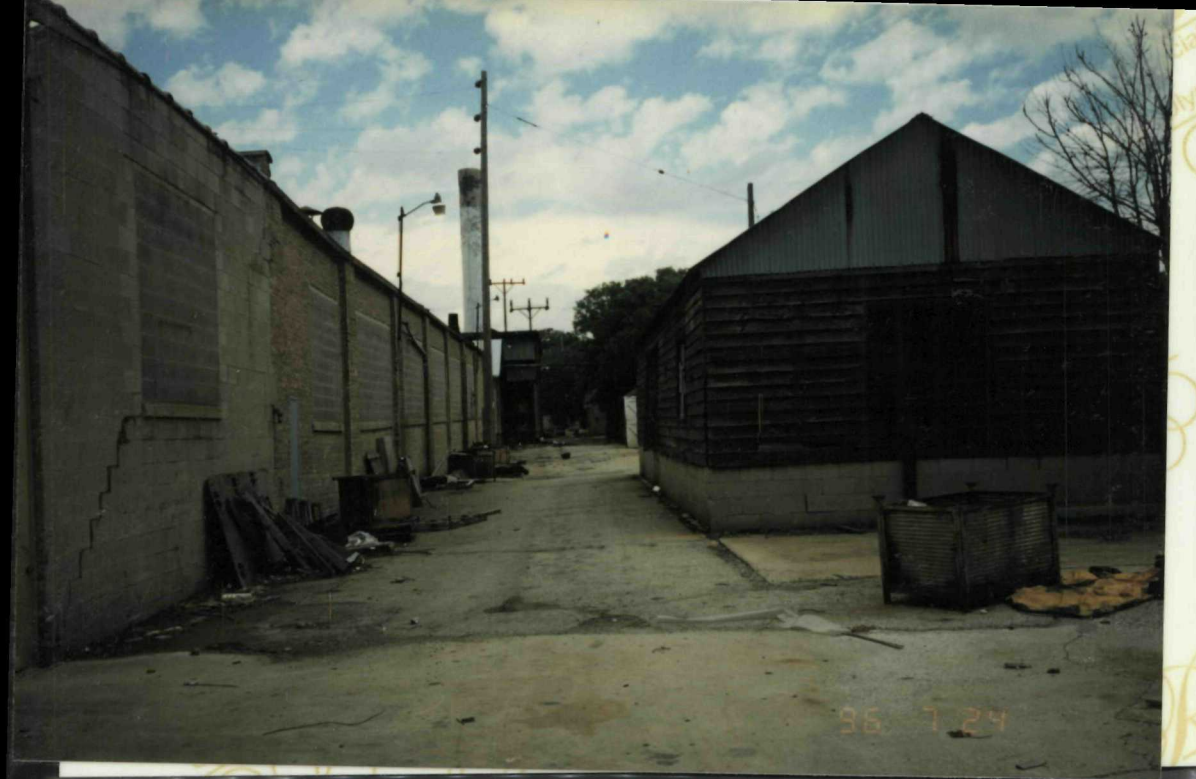
Site: Frost Manufacturing Company **Date:** 7-24-96 **Direction:** North
Camera: Olympus Infinity 35mm **Photographer:** J. Nordine
Subject: A view of the alley to the north.

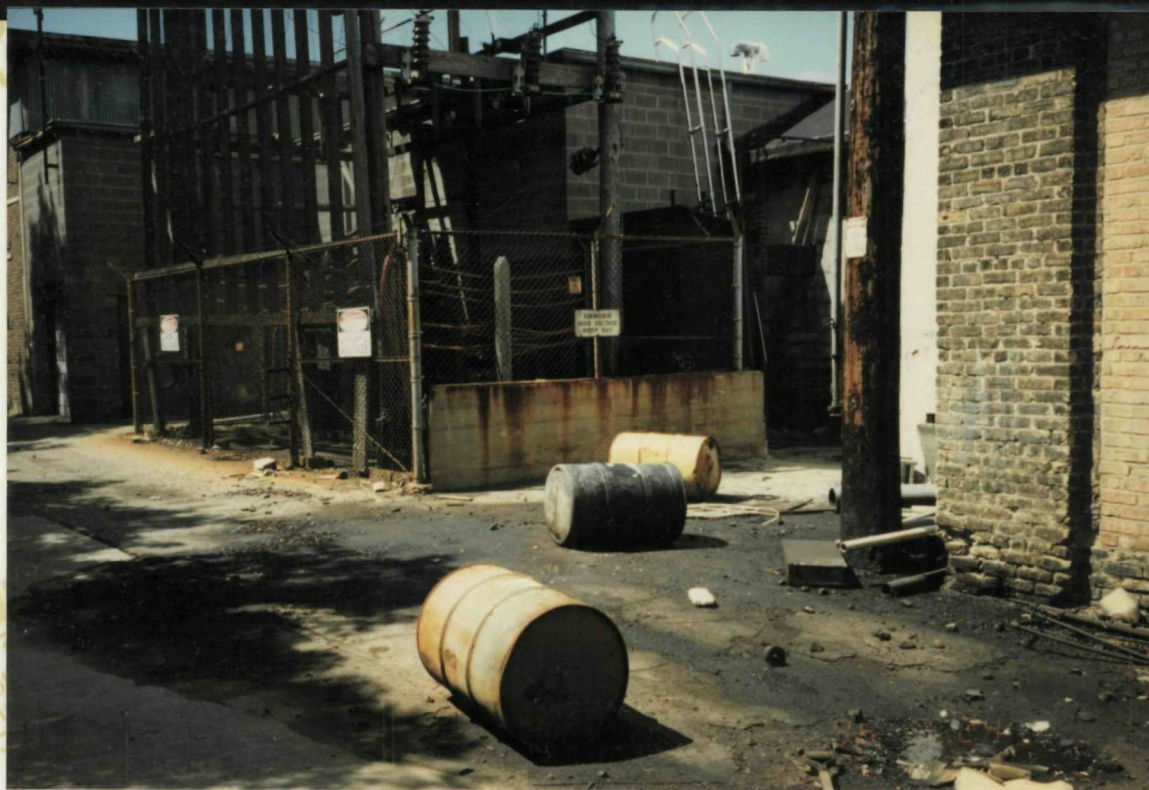
Site: Frost Manufacturing Company **Date:** 7-24-96 **Direction:** Southwest
Camera: Olympus Infinity 35mm **Photographer:** J. Nordine
Subject: Three 55-gallon drums that have been tipped over in the alley on the east side of the main plant building. The drums spilled an oily liquid onto the concrete and into a drain in the alley. Note the large electrical transformers in background.

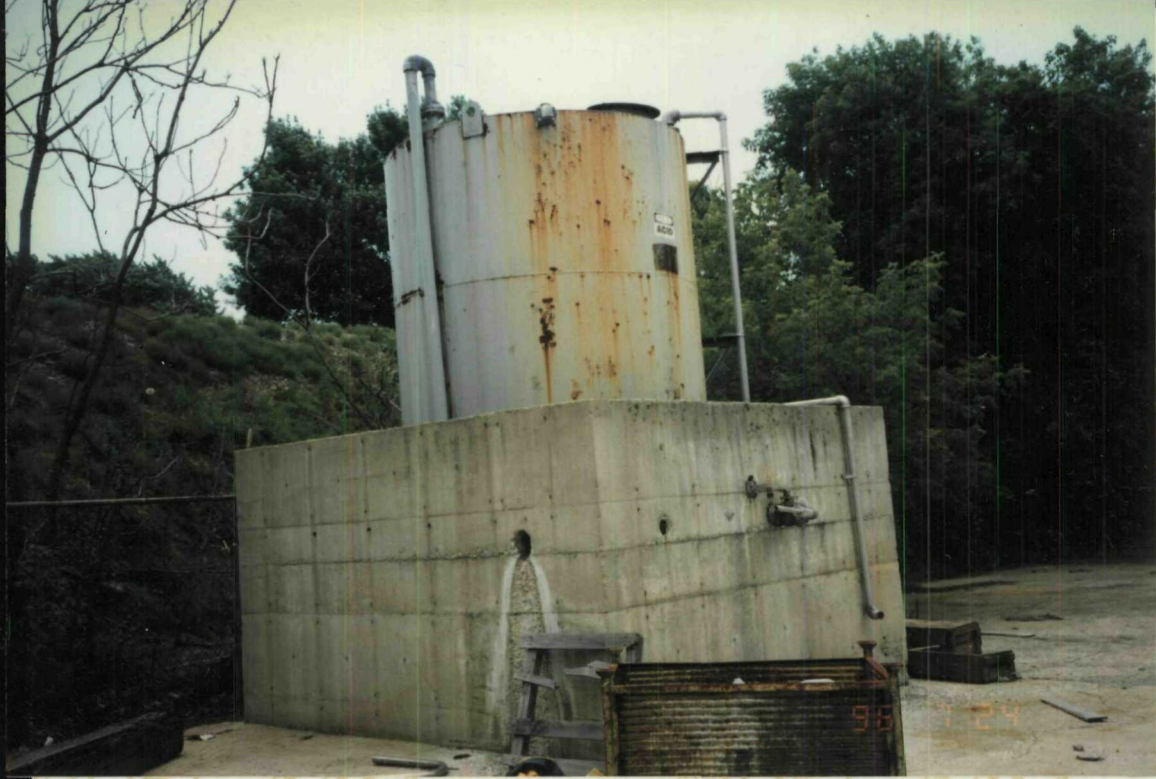
Site: Frost Manufacturing Company **Date:** 7-24-96 **Direction:** East
Camera: Olympus Infinity 35mm **Photographer:** J. Nordine
Subject: 3,000-gallon vertical tank labeled "acid" located on the east side of the main plant building.

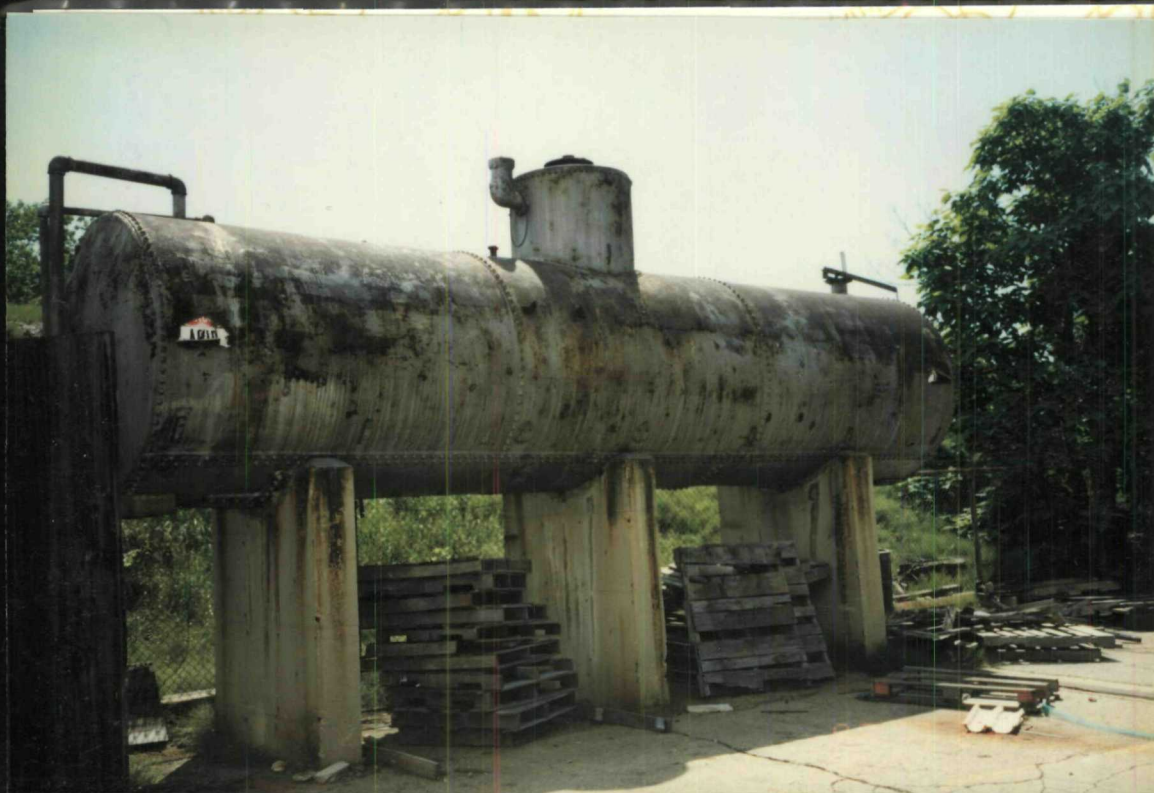
Site: Frost Manufacturing Company **Date:** 7-24-96 **Direction:** East
Camera: Olympus Infinity 35mm **Photographer:** J. Nordine
Subject: 2,500-gallon horizontal tank labeled "acid" located on the east side of the main plant building.

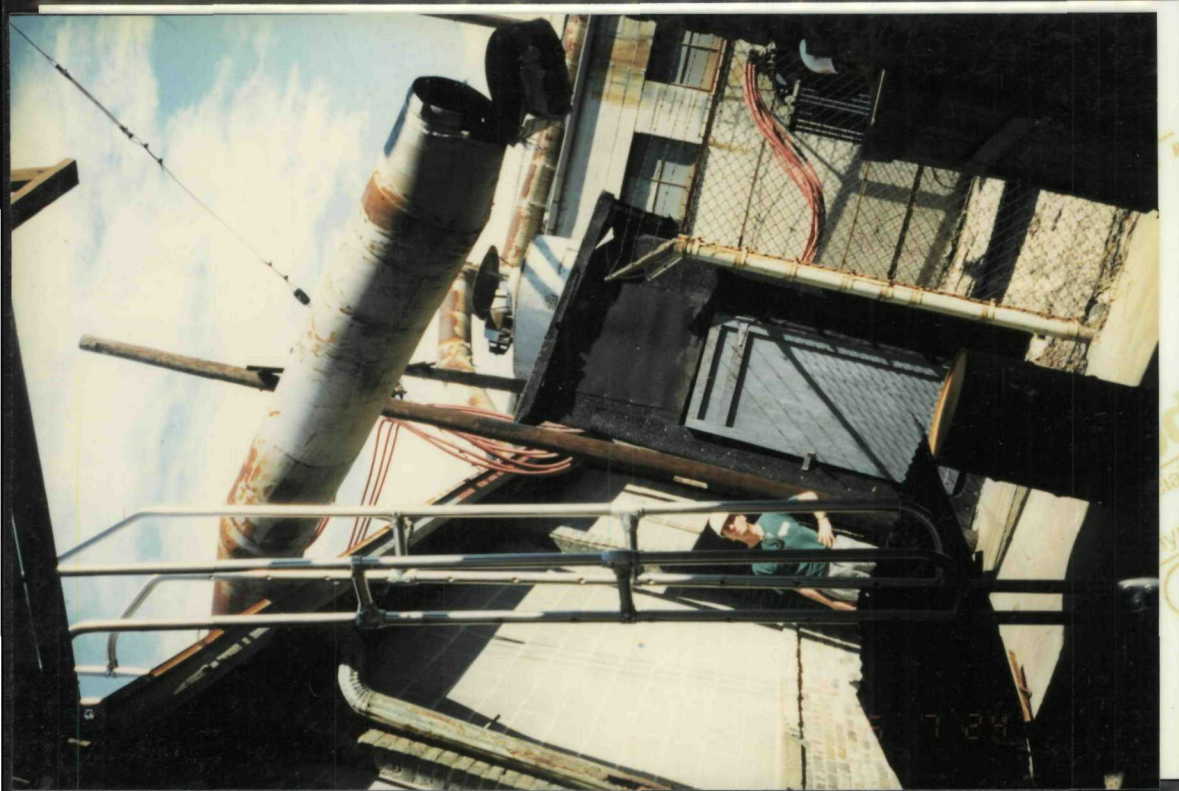
Site: Frost Manufacturing Company **Date:** 7-24-96 **Direction:** West
Camera: Olympus Infinity 35mm **Photographer:** J. Nordine
Subject: The pool ladder used to gain access to the roof of the main plant building.

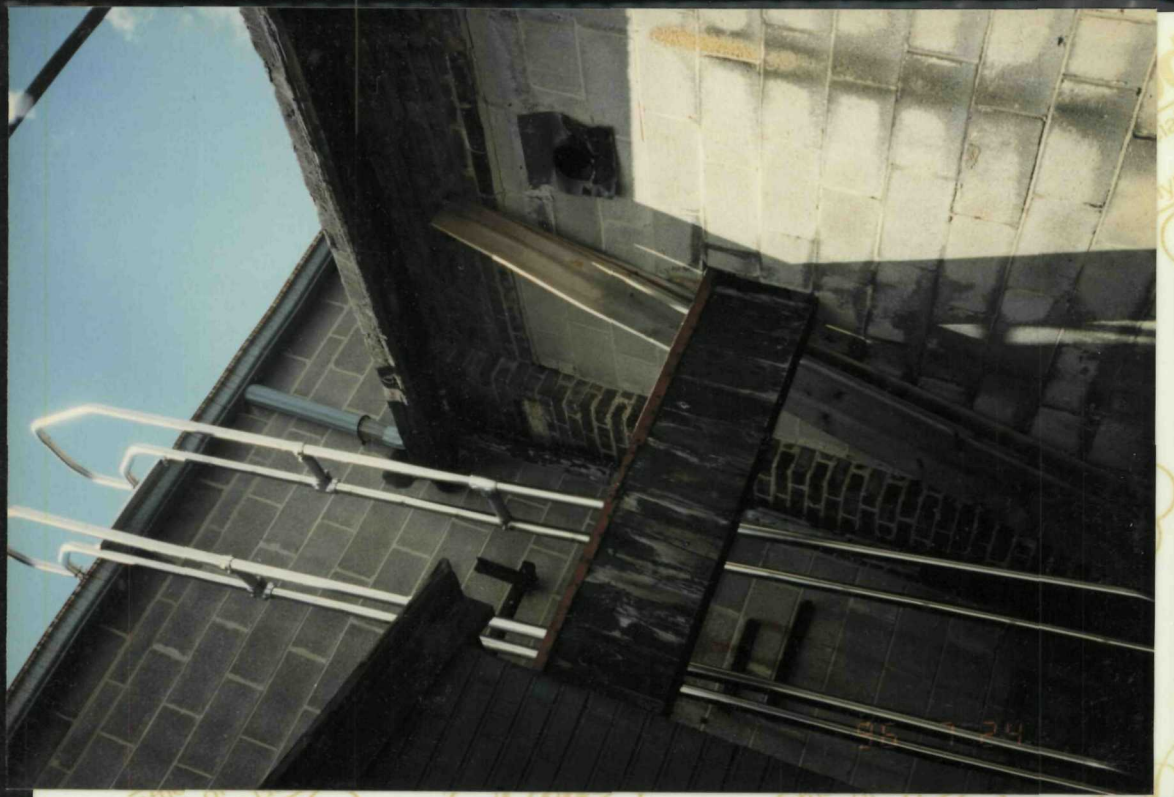
Site: Frost Manufacturing Company **Date:** 7-24-96 **Direction:** Southwest
Camera: Olympus Infinity 35mm **Photographer:** J. Nordine
Subject: A second pool ladder used to gain access to the roof of the main plant building.
